# PRODUCT UPDATE (PU)

**BULLETIN** : PU-23-01 October 12, 2023 (3 pages)

**SYSTEM** : Electrical

**AFFECTED TANKS:** 621G (SK8SC-005 to -009), 725 Articulated Truck (SN SK5AT-009 to -0016), 730 Articulated Truck (SN SK6AT-003 to -0019), 740 Articulated Truck (SN SK8AT-005 to -0010), 745 Articulated Truck (SN SK9AT-001 and SK9AT-004)

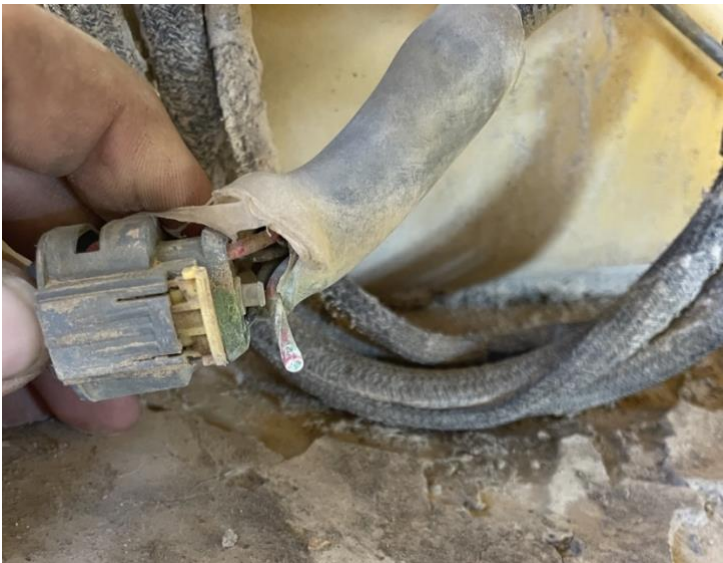
Below: water intrusion corroding wire.

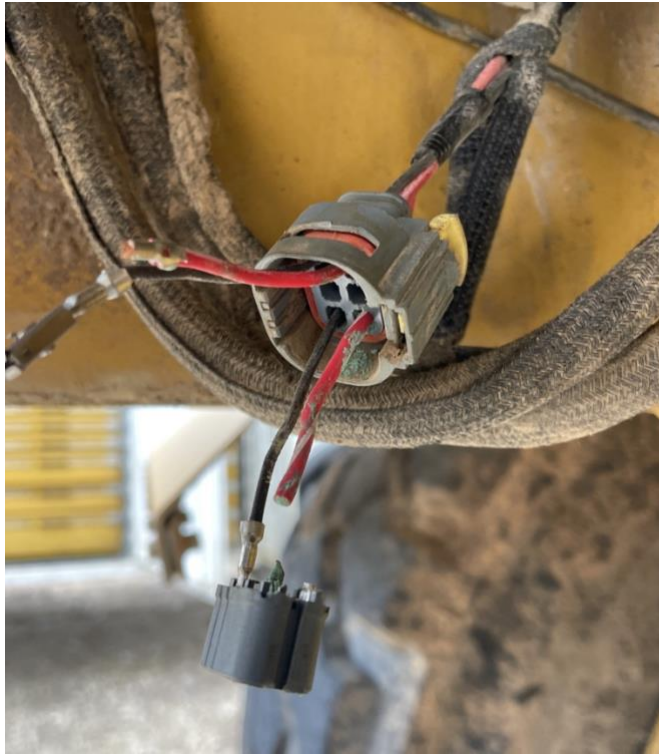
Pin to wire connection failure.
