PRODUCT UPDATE (PU)

BULLETIN : PU2024-01 (2 pages)

SYSTEM : Spray Heads

AFFECTED TANKS: All with Spray Heads

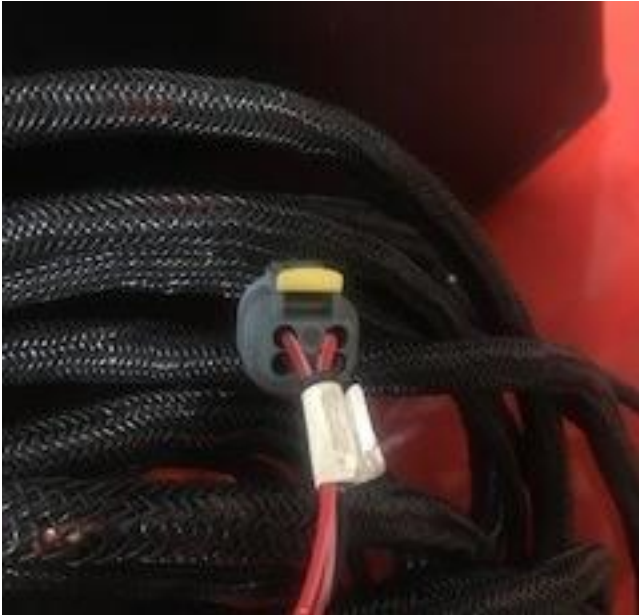
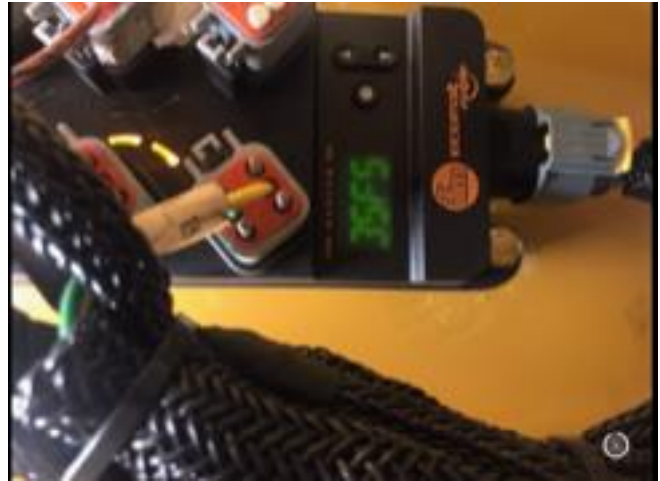
Missing wire seals. In connector CON17 main power into IFM controller.

COMPLETION : Inspect, replace connector, pins, and install wire seals. Reuse two cavity plugs.

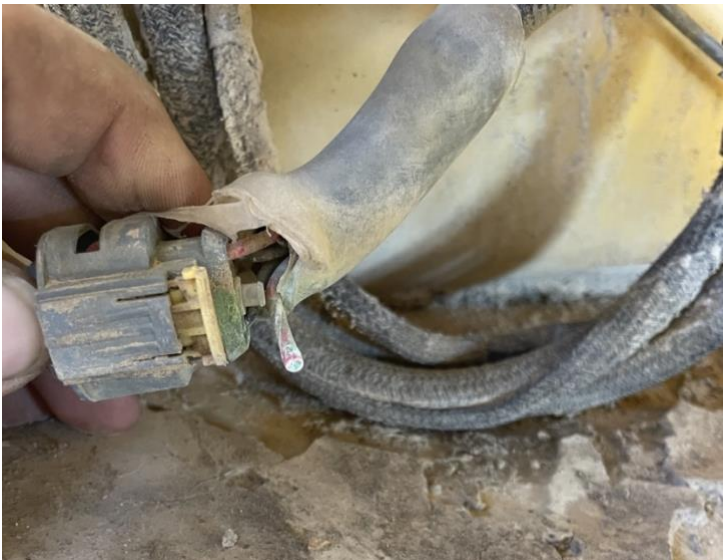
REASON : Truck will not start. Active Code on Chassis ECM (Shift hoist voltage high); Spray King IFM controller not broadcasting voltage to shift hoist circuit. Failure: Possible water intrusion at IFM power and ground connector causing failure (Con17).

Below: water intrusion corroding wire.

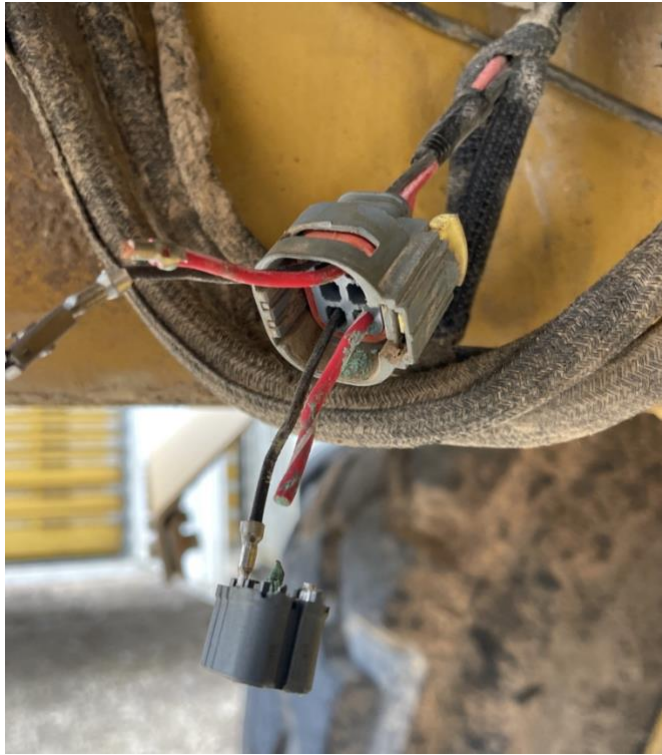
Pin to wire connection failure.
